## CHAKAR MOSQUE IN KARSHI

**Gilmanova Nafisa Valiakhmetovna**

Doctoral student (DSc) of Tashkent  
Architecture and Civil Engineering University  
City of Tashkent, Republic of Uzbekistan  
Email: [nafisa\\_gilmanova@mail.ru](mailto:nafisa_gilmanova@mail.ru)

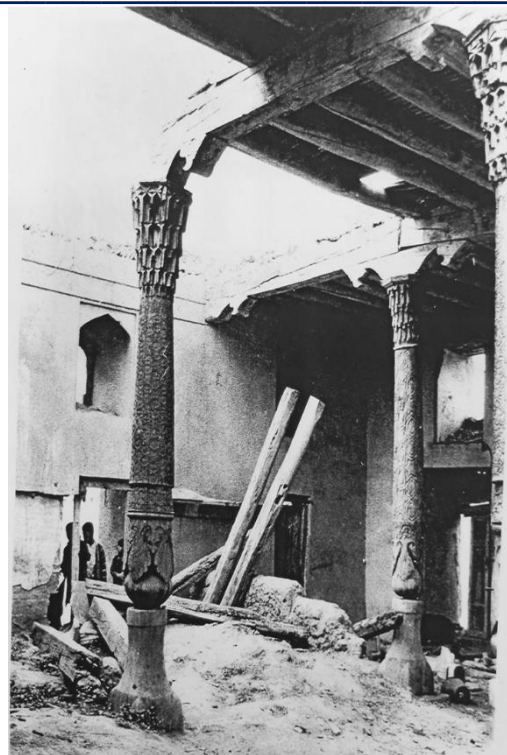
Состояние мечети до реставрации.

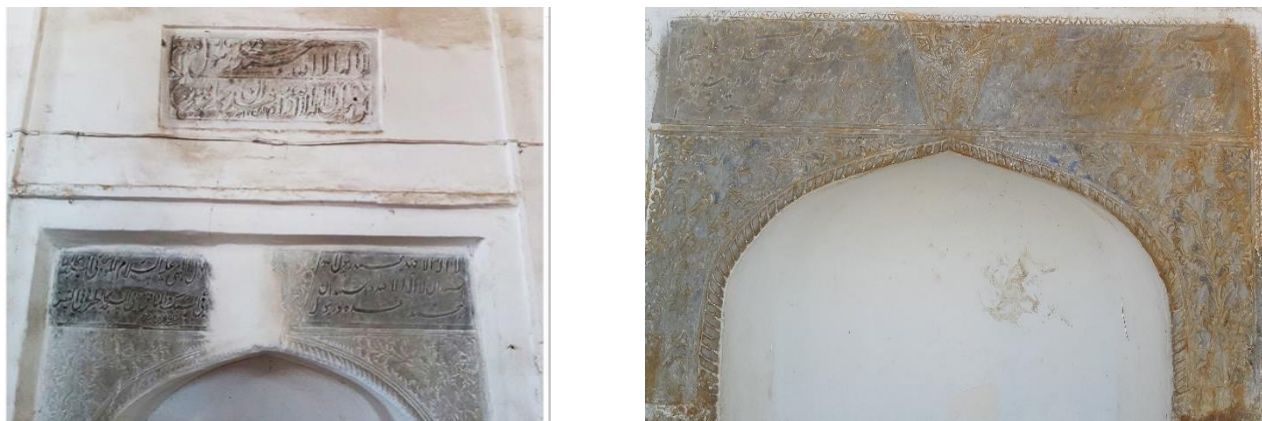
**Tympanums and ikrabs with painting and epigraphy. Photo 2021**

The tympanums of the two mihrabs of the Chakar Mosque (Kashkadarya, XVIII century) depict flower bushes similar to a tree. There is also the idea of reminding parishioners of the Garden of Eden.<sup>5</sup>

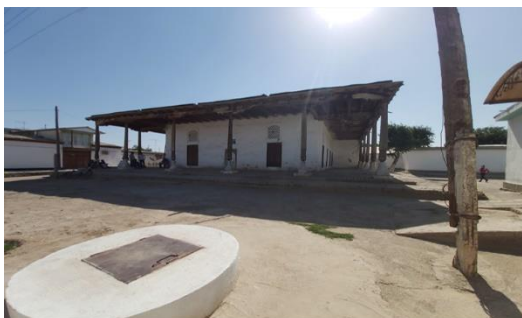
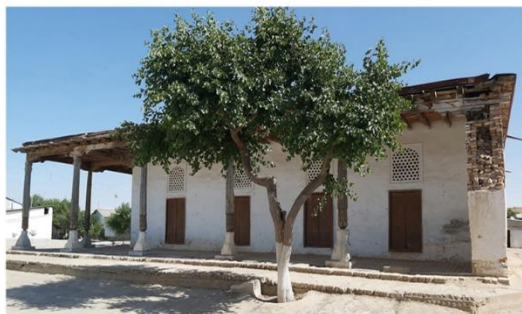
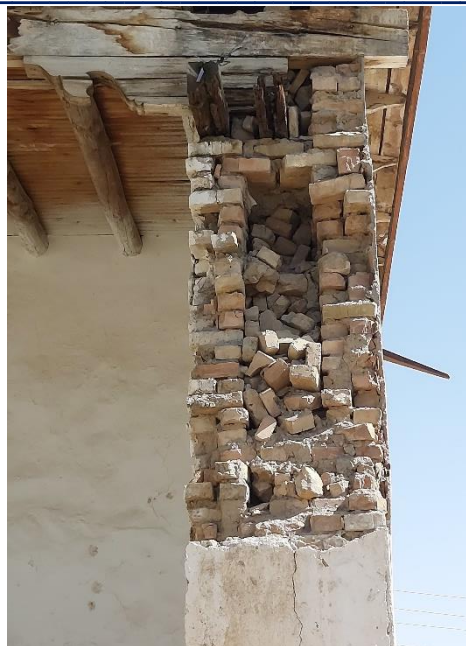
In recent years, the mosque has fallen into disrepair. The beam ceiling of the hall was dismantled, six unique carved columns remained in the open air. The iwan is destroyed, the hall is cluttered. Currently, a unique architectural monument of the first half of the XIX century is being destroyed and can be irretrievably lost. Restoration, repair, emergency and other works were not carried out.<sup>6</sup>

The iwans that previously existed on the three sides have been completely lost. At the site of the existing iwans, you can read traces of the floor beams and the places of passage of the foundations, which requires a detailed examination by pits. When conducting research work in kind and developing a restoration project, it is necessary to pay special attention to the condition of the foundations and their depth, to the calculations of the newly constructed structures of the mosque.

According to interviews of local guards and the stories of a resident of the makhalla Ulugbek Ikramov, it was found out that on the site of the existing mosque, its construction was previously recorded even more ancient, the entrance was on the right side of the mosque at the base of the foundation and went down for three meters, where they went down and climbed the stairs. The lower part of the room had an iron door, about two meters in size. At the moment, the entrance of the lower structure is with a span of earth. A little further than the mosque, the plan shows that there was a minaret. The old well is also located in front of the mosque on the right side, about 10 meters away and it is local. According to the residents of the mahali, the mosque used to be surrounded by mulberry trees, which protected the foundation of the structure from dampness and moisture. In the construction of the mosque, blue marble was previously used, which was used earlier for the construction of mosques. According to the latest research, the mosque does not function, is not in the best condition, part of the supporting wall is being destroyed, and high-quality authentic restoration is required.

**General view of the mosque and the destroyed part of the wall adjacent to the mosque**

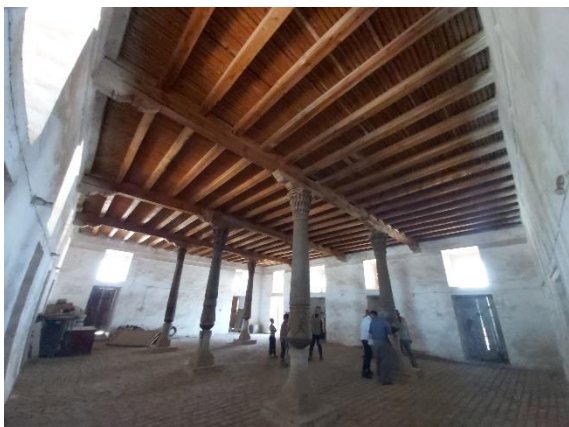
**Hall of the mosque with columns**

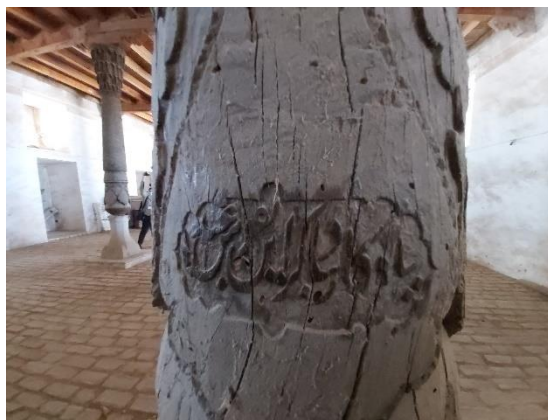
It is still dated to epigraphy within the first half of the XIX century. On the column of the mihrab there is a carved date of 1223 a.h. (1807). In addition, a similar inscription made in the painting is also found above the mihrab - 1259 a.h. (1847). There is also another date in small print - 1323 a.h. (1905). - apparently, by the hand of a pilgrim. The first dates are obviously associated with the construction of the mosque.

**The inscription preserved on one of the columns, with the date of construction of the mosque**
