INVESTIGATION OF THE MICROSTRUCTURE AND HARDNESS OF 20GL STEEL SAMPLES CUT FROM A WEDGE-SHAPED AND A SIDE FRAME AFTER VOLUME-SURFACE QUENCHING

Article history:	Abstract:
Received: 17 th April 2021 Accepted: 30 th April 2021 Published: 31 th May 2021	This work is devoted to the topic "Investigation of the microstructure and hardness of 20GL steel samples cut from a wedge-shaped and a side frame after volume-surface quenching". Recently, the railways of Asia and the Russian Federation are more than two dozen fractures of the side frames of trucks of freight cars every year. Each case is a potential source of an accident or crash. In addition, when carrying out scheduled repairs of freight cars, about a thousand side frames and truck bolsters are rejected.

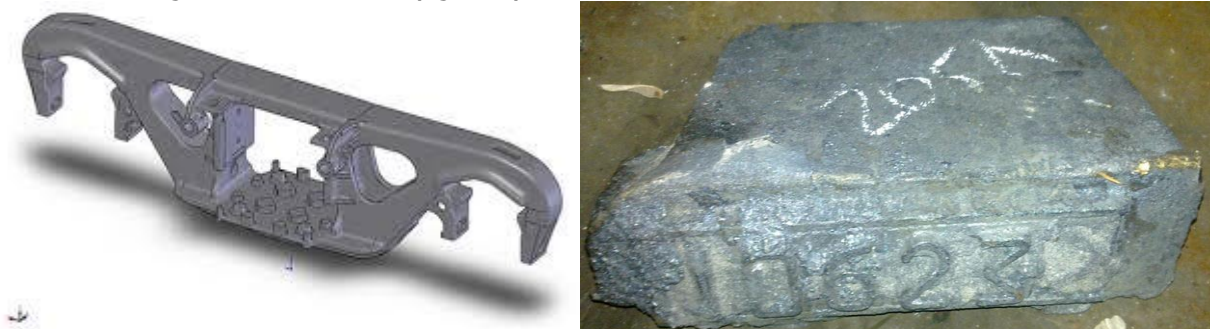
The study of the structure was carried out at various scale levels: macro, micro. For the research, samples were made, cut from a wedge and a side frame (figure 1).

Figure 1-Side frame (a) and process sample (wedge-shaped) (b) of 20GL steel

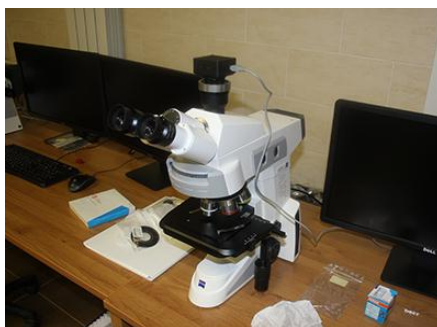
The sections were examined by optical microscopy using an Axio Lab A1 Carl Zeiss microscope (Figure 3) in the reflected light mode. The sample was placed on a slide table, so that the surface of the slot was on top.

Figure 3 - Photo of the Axio Lab A1 Carl Zeiss microscope

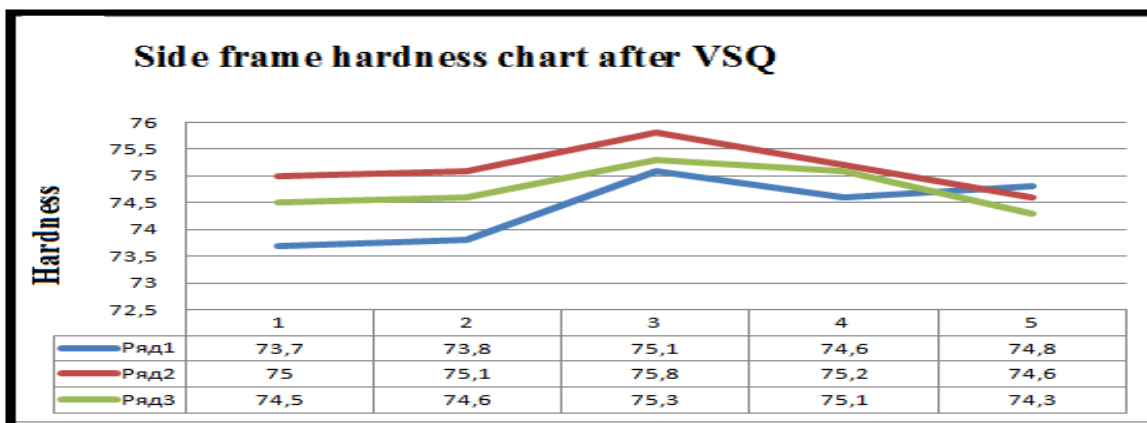
Figures 12-13-14-15 show the hardness diagrams of the samples after normalization and after volume-surface quenching.

Figure 13-Side frame hardness distribution after VSQ (HRA)

The diagrams showed that the hardness of the samples of the side frame and the wedge-shaped sample increases after volume-surface quenching. The values of the hardness of the side frame and the wedge after the VSQ coincide and are in the range of 55-65 HRA.

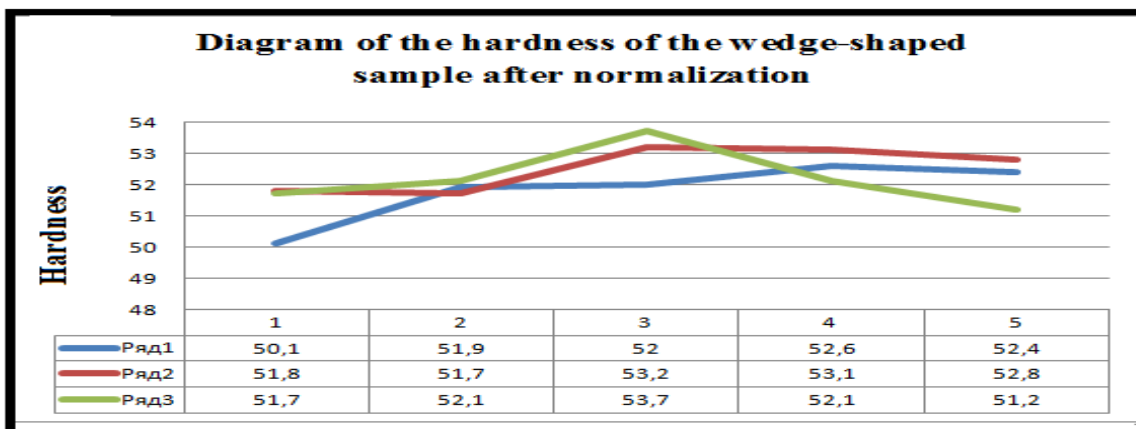
Figure 14-Wedge-shaped hardness distribution after normalization (HRA)
